June 28, 2019
File No. 262018.063

Subject: Department of Natural Resources Washington Geological Survey,
School Seismic Safety Assessment Project, Contract No. AE 410 -
Seismic Evaluation for **Naches Valley School District**

Naches Valley, Naches Valley High School, Gym Building

Naches Valley, Naches Valley Middle School, Main Building

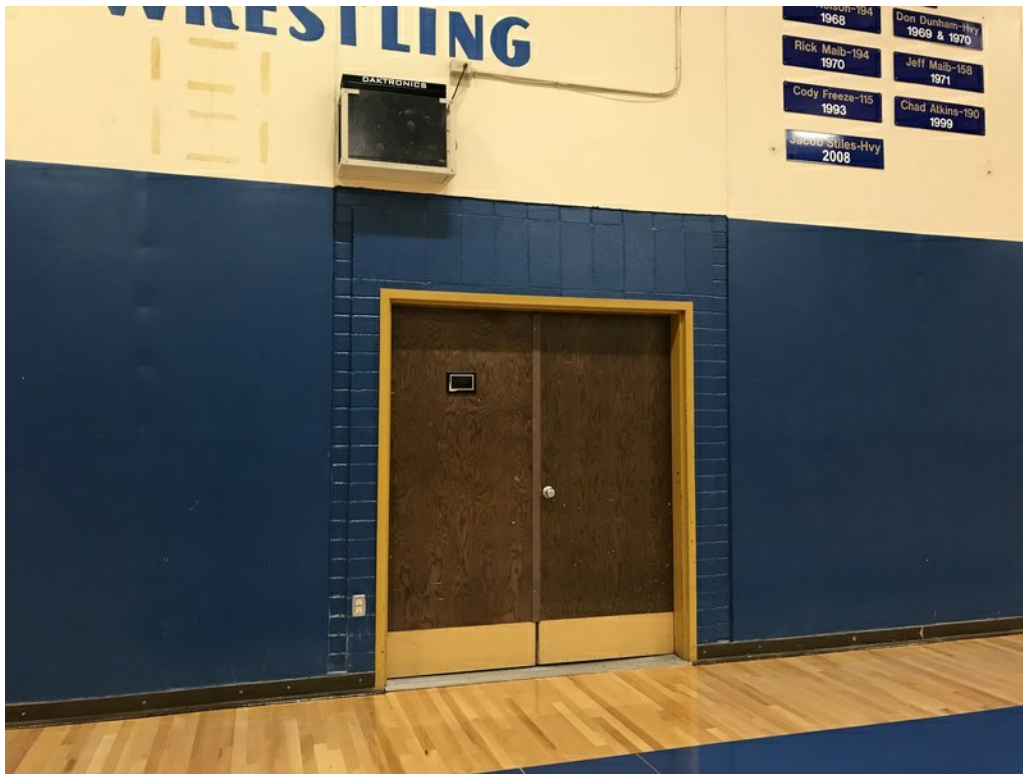
Figure 1-5. Naches Valley HS Gym cmu infill at door

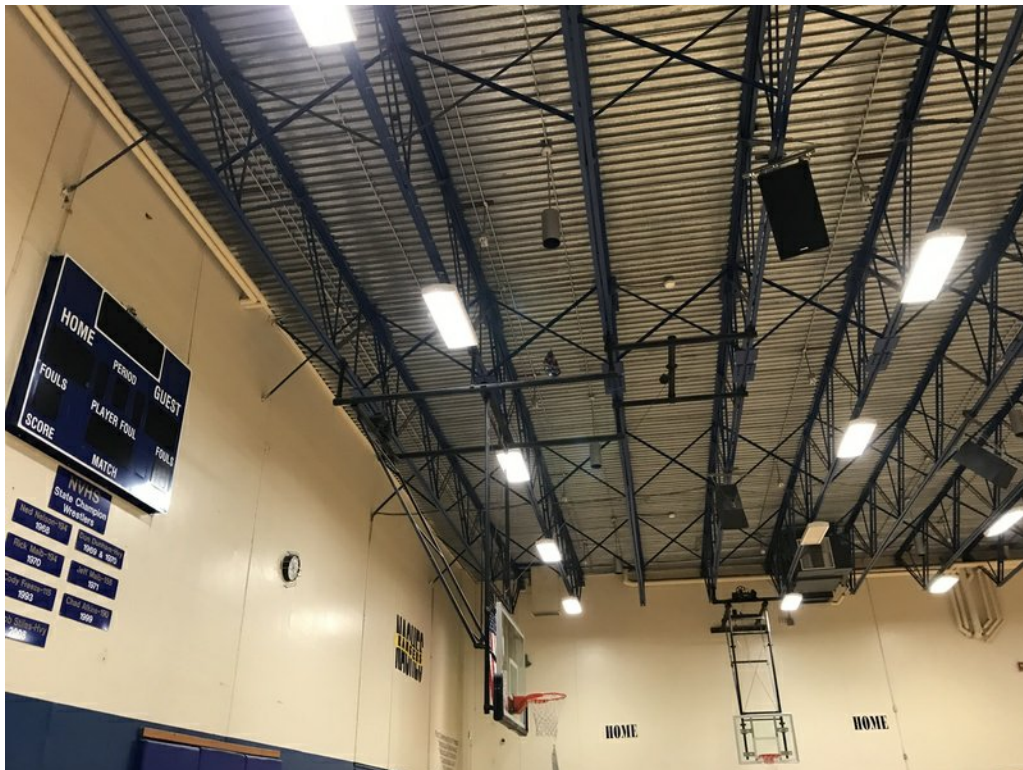
Figure 1-6. Naches Valley HS Gym Roof

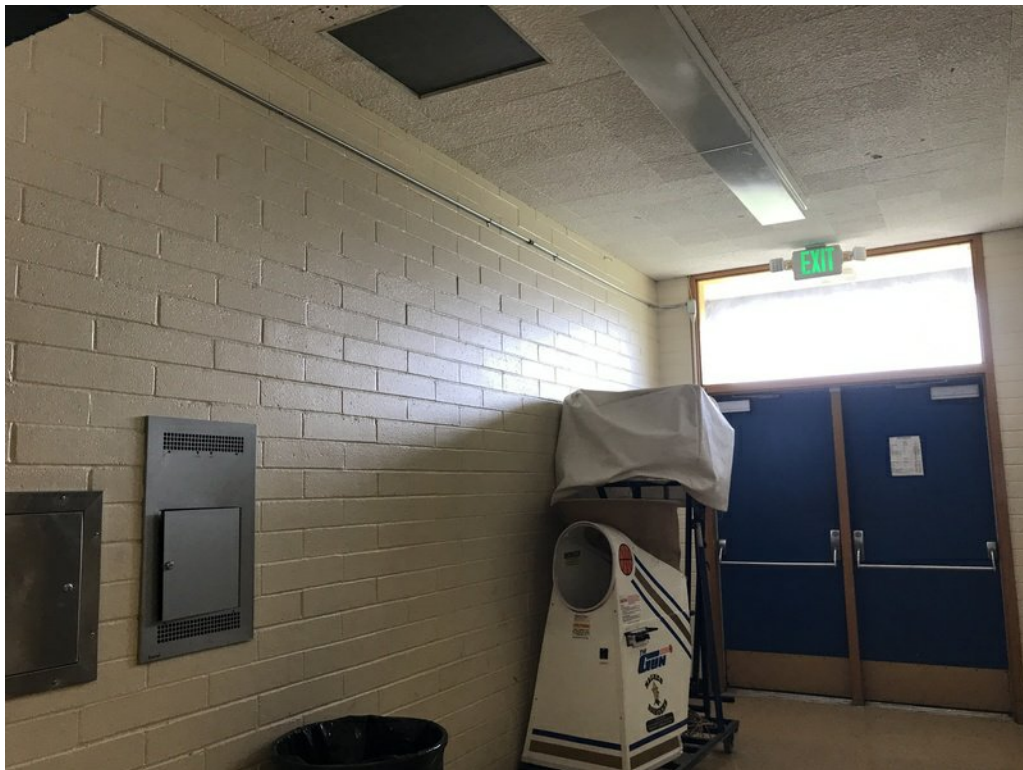
Figure 1-8. Naches Valley HS interior brick wall

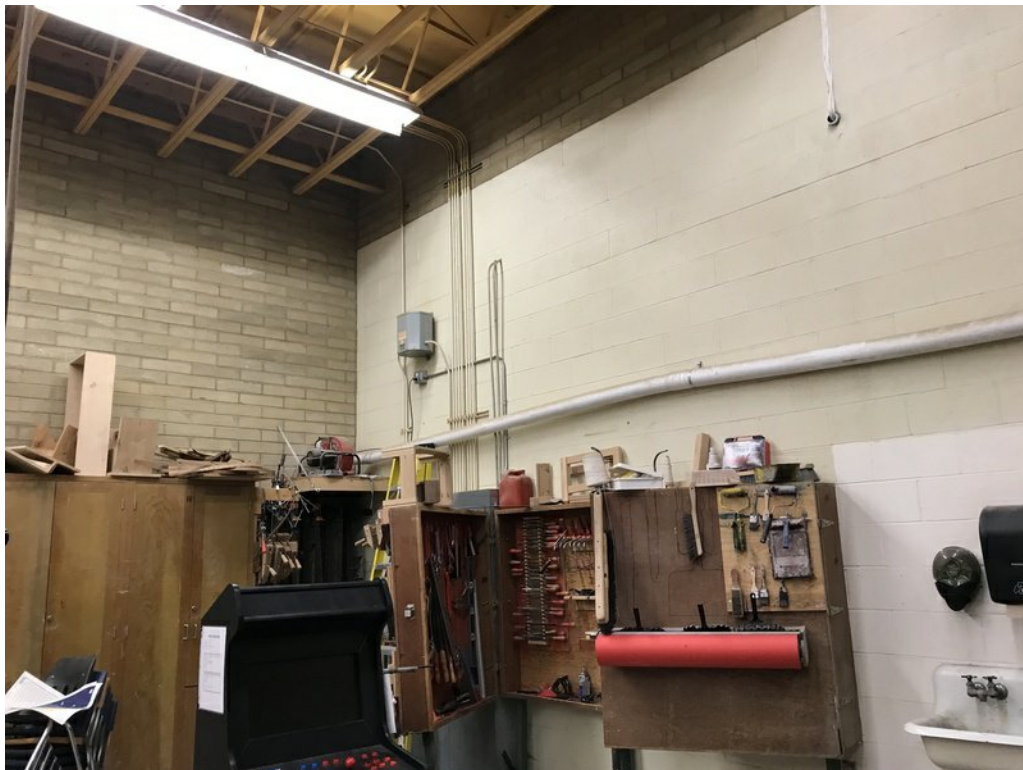
Figure 1-8. Naches Valley HS Voc Tech joint cmu to brick

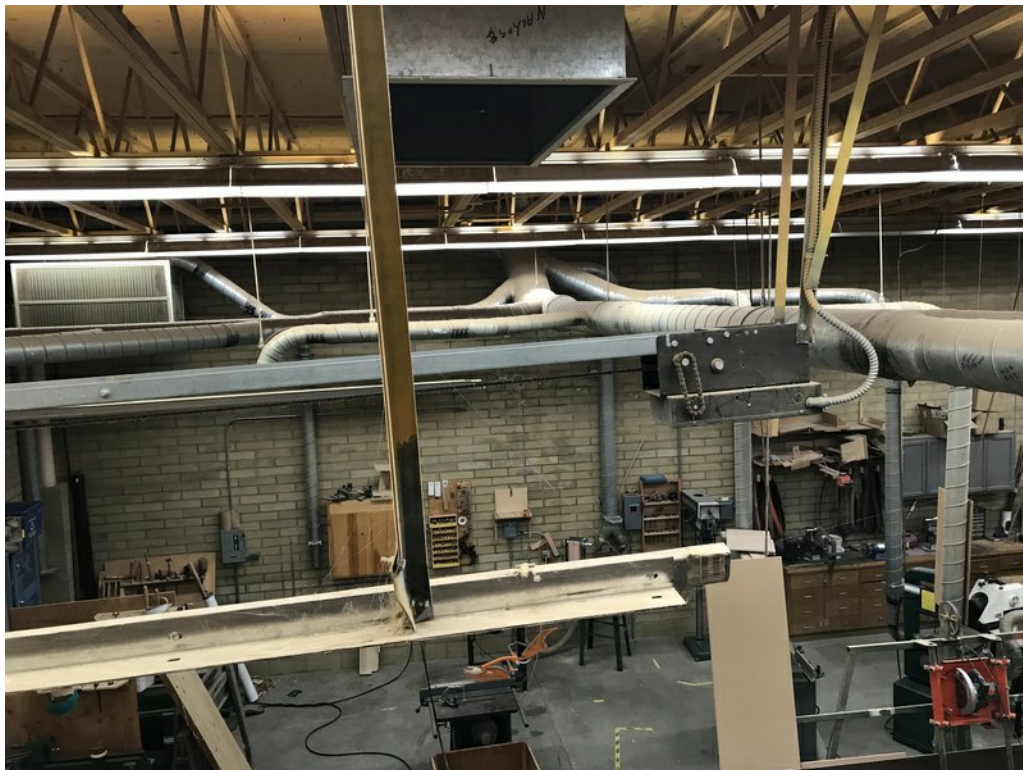
Figure 1-10. Naches Valley HS Voc Tech roof & suspended mechanical

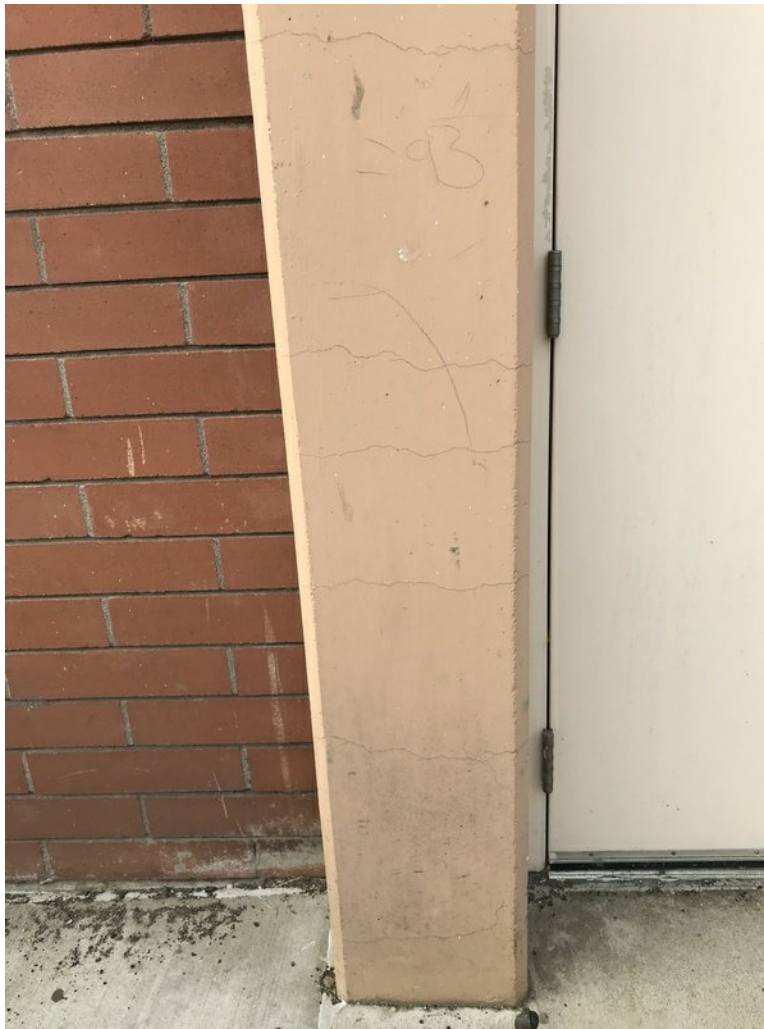
Figure 1-8. Hairline cracks at gym column

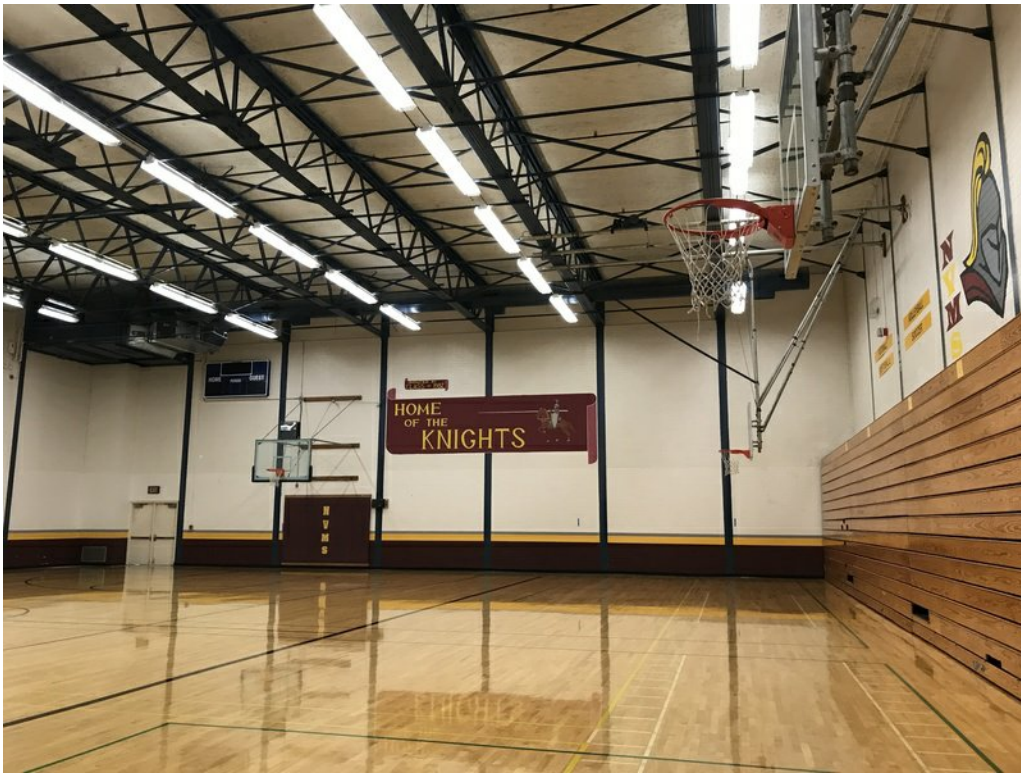
Figure 1-9. Naches Valley gym roof construction
